## **NATIONAL TRANSPORTATION SAFETY BOARD**

# **WRECKAGE EXAMINATION SUMMARY**

**WPR15FA195**

Location:	Maricopa, CA
Date:	June 22, 2015
Aircraft:	N206PZ; S312 Tucano T MK1
NTSB Investigator-in-Charge:	Andrew Swick

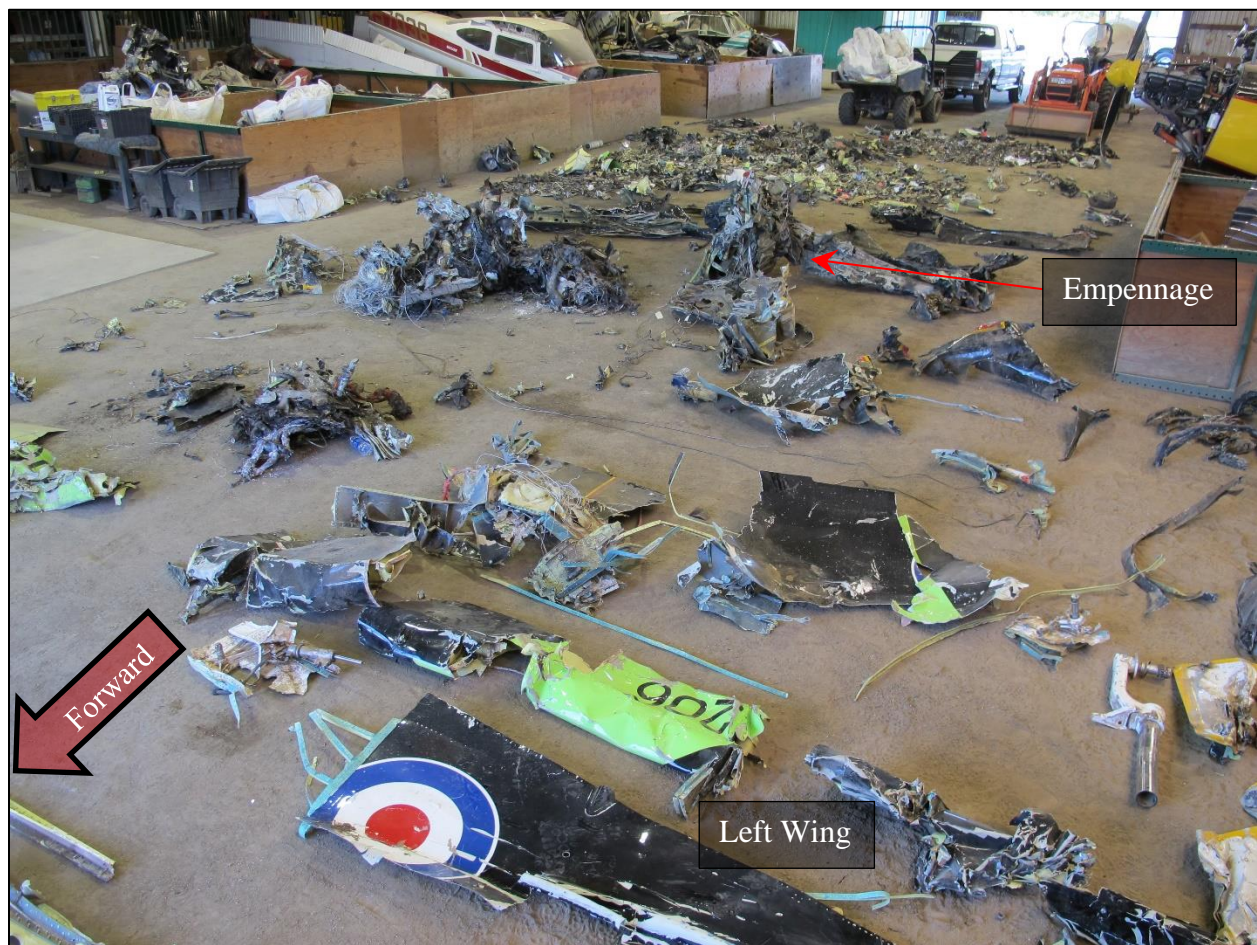
**Figure 1. Wreckage Layout**

Examination of the recovered wreckage was conducted on June 25 and 26, 2015 at the facilities of Plain Parts in Pleasant Grove, California, by the National Transportation Safety Board (NTSB) investigator-in-charge (IIC), Federal Aviation Administration (FAA), and Honeywell Aerospace. The examination revealed no evidence of any pre-collision mechanical malfunctions or failures that would have precluded normal operation.

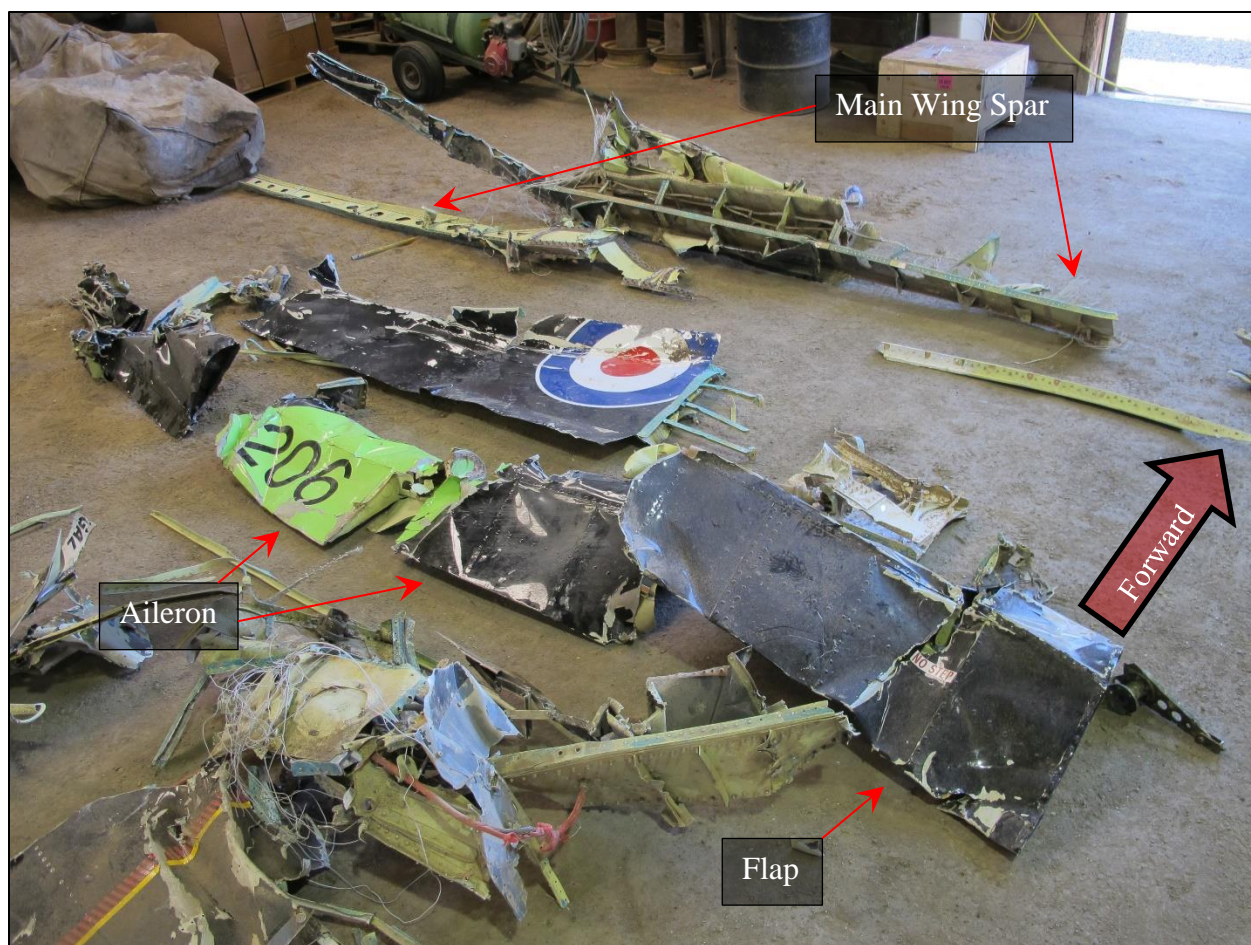
**Figure 2. Wreckage Layout, Left Wing**

The wing sections were displayed on the ground and revealed leading edge crush damage. The main spar was found in several sections with bending near the midsection. Each of the ailerons were found in two, 3-foot sections. The left-wing flap was identified and had evidence to suggest it was in the retracted position during impact.

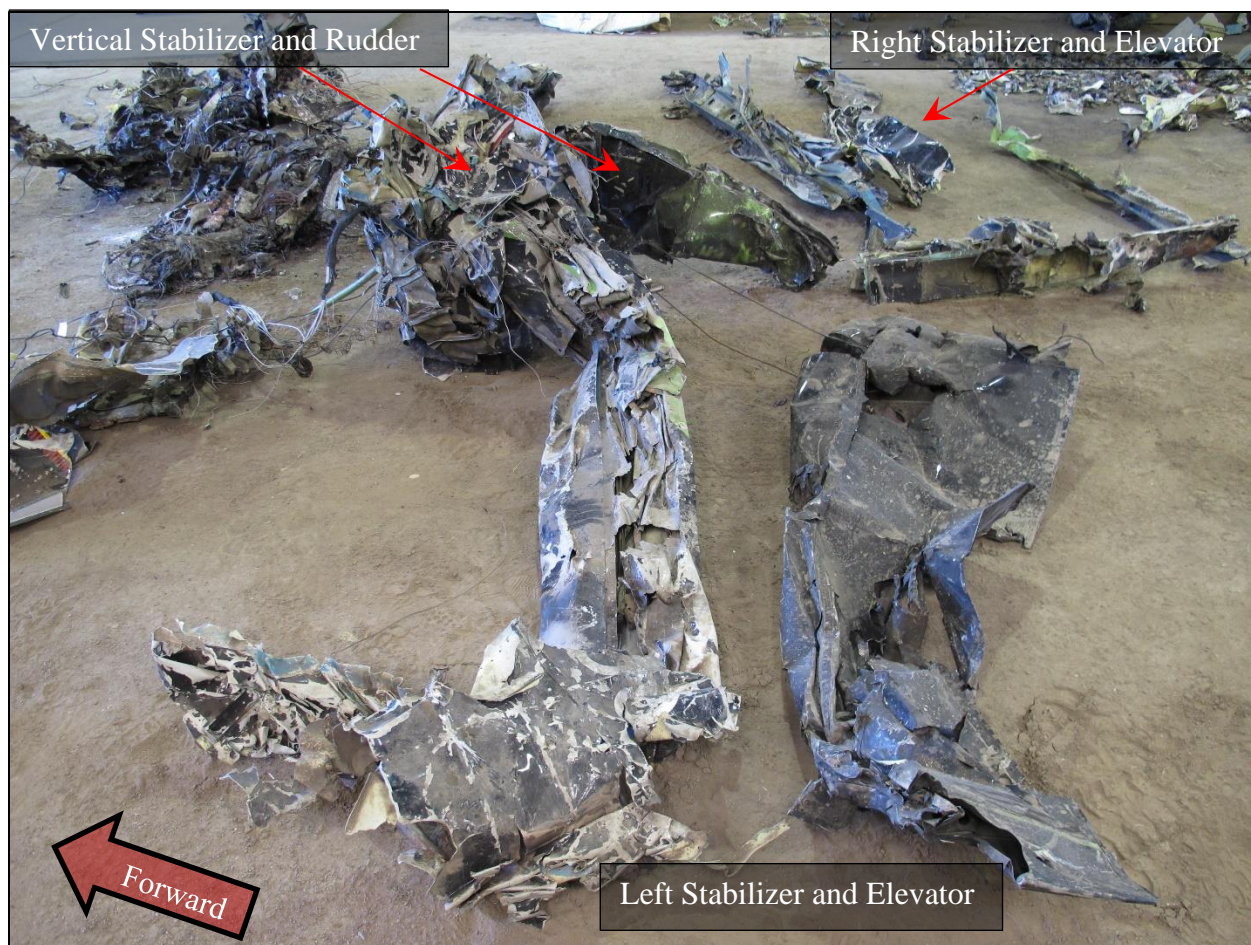
**Figure 4. Empennage**

Both elevators and horizontal stabilizers had impact damage and were crushed. The trim actuator shaft had separated mid-span and 45-degree shear lips were observed on the separation surfaces. The trim actuator shaft was measured from the shaft bolt to the rubber seal and was 3.845 inches in length. During the examination of an exemplar airplane, this measurement was equated to be about .5 (near neutral) pitch trim position.

The rudder and vertical stabilizer had impact damage and remained attached via rudder control cables. The vertical stabilizer and aft fuselage remained attached.

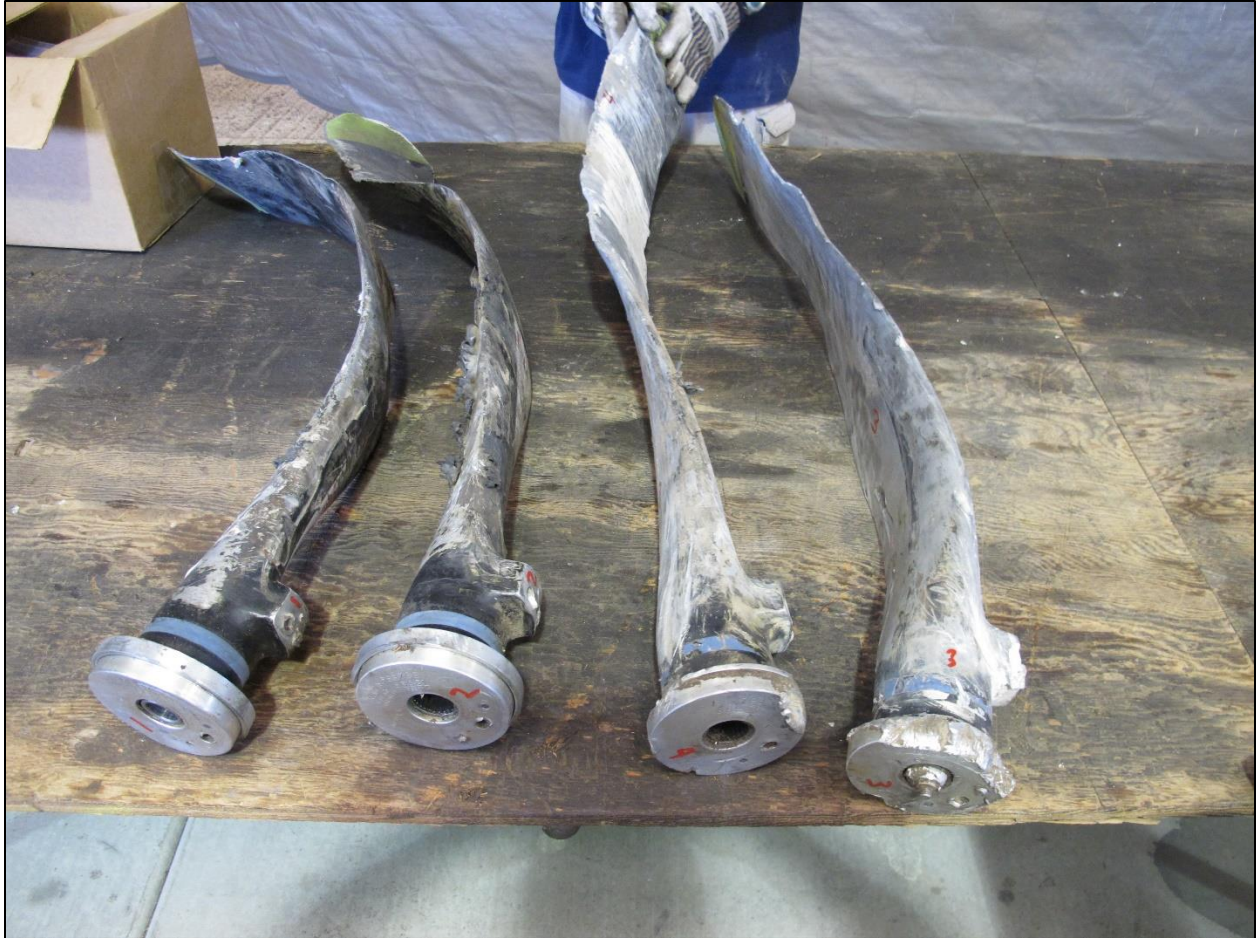
**Figure 5. Propeller Blades**

The propeller assembly separated from the engine during the accident sequence and had impact damage. The cylinder, piston, feathering spring and hub were found separated into numerous sections. Hub sections were removed from two of the blade shanks. The blades revealed leading edge gouging and chordwise scoring from the shank areas to the tips. Two of the blades were bent rearward from the midsection to the tip, and had a decreased pitch twist from the midsection to the tip. Another blade had a slight bend rearward and the last blade was bent forward from the midsection to the tip. For further information see the Hartzell Propeller Teardown Report in the public docket for this accident.

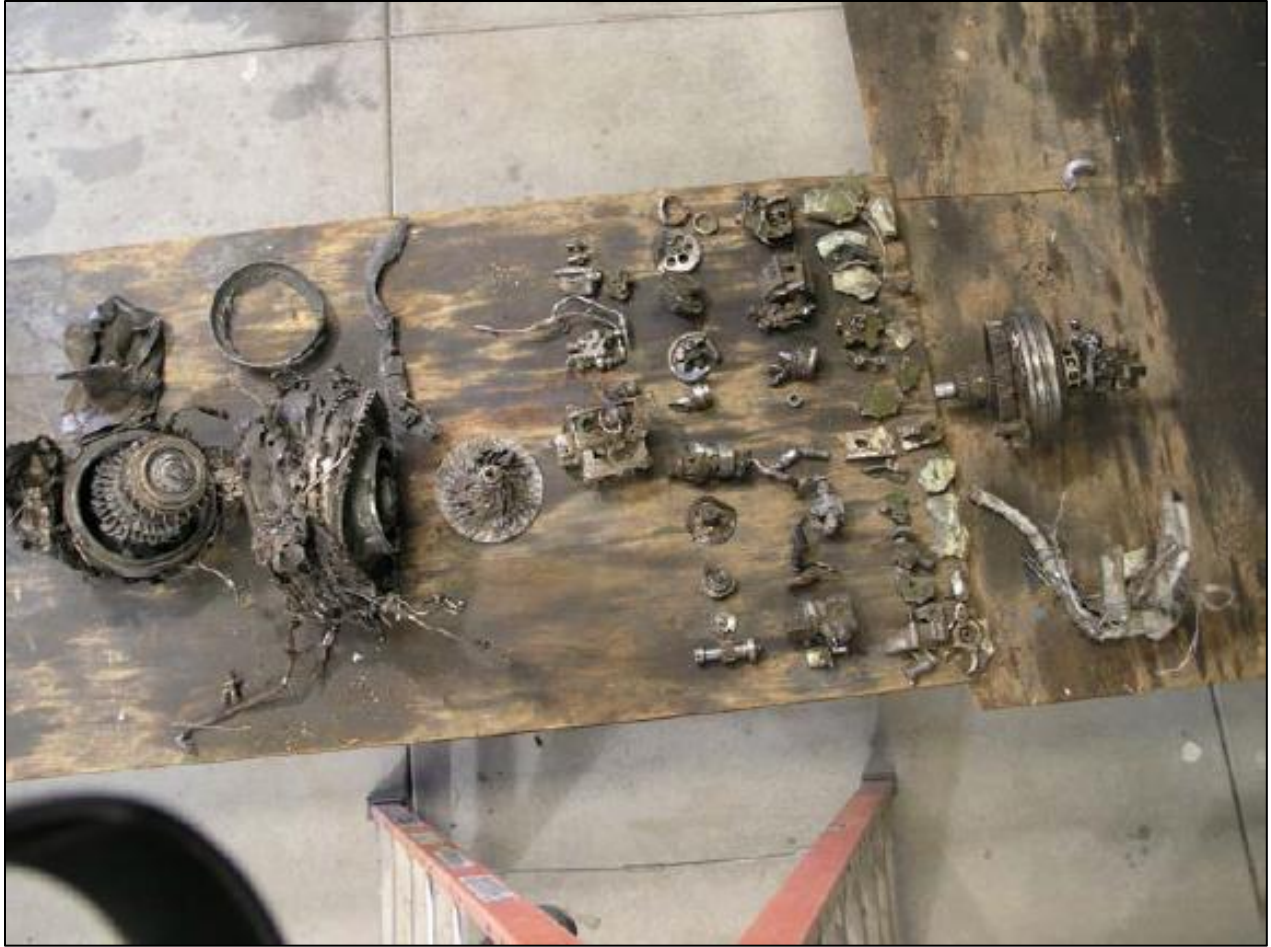
**Figure 6. Recovered Engine and Components**

The engine was found in three major sections; the bull gear, second-stage compressor housing and impeller, and the turbine stator outer vane support housing. Other loose engine parts were found in the debris field. The engine revealed damage signatures consistent with an engine operating at power settings during the impact sequence. For further information see the Engine Wreckage Examination Notes in the public docket for this accident.

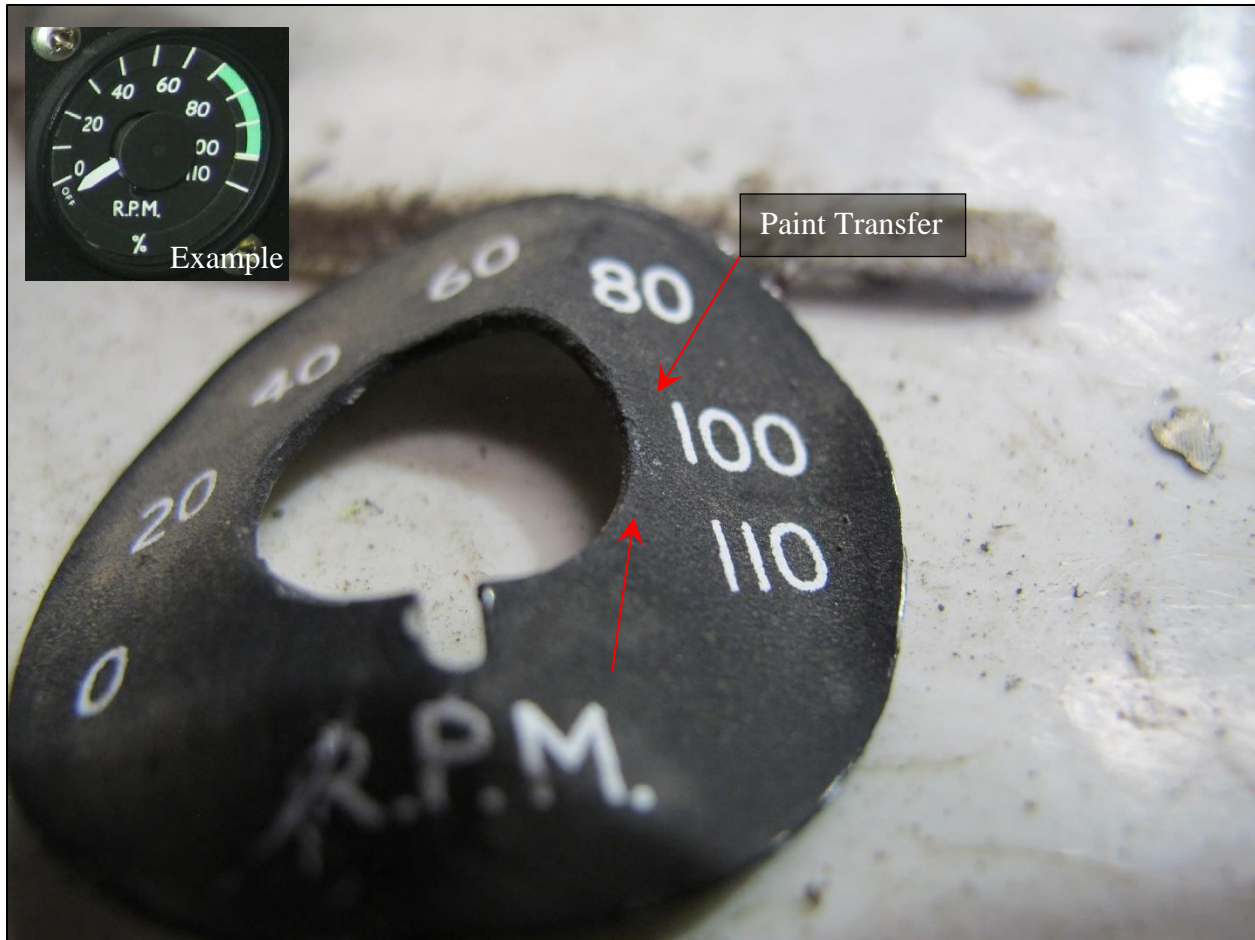
**Figure 10. Instrument, R.P.M. Gauge**

The cabin instruments separated from the instrument panel and had impact damage. The R.P.M. gauge face separated from the instrument housing and was bent. White paint transfer marks are visible near the '100' displayed on the face.

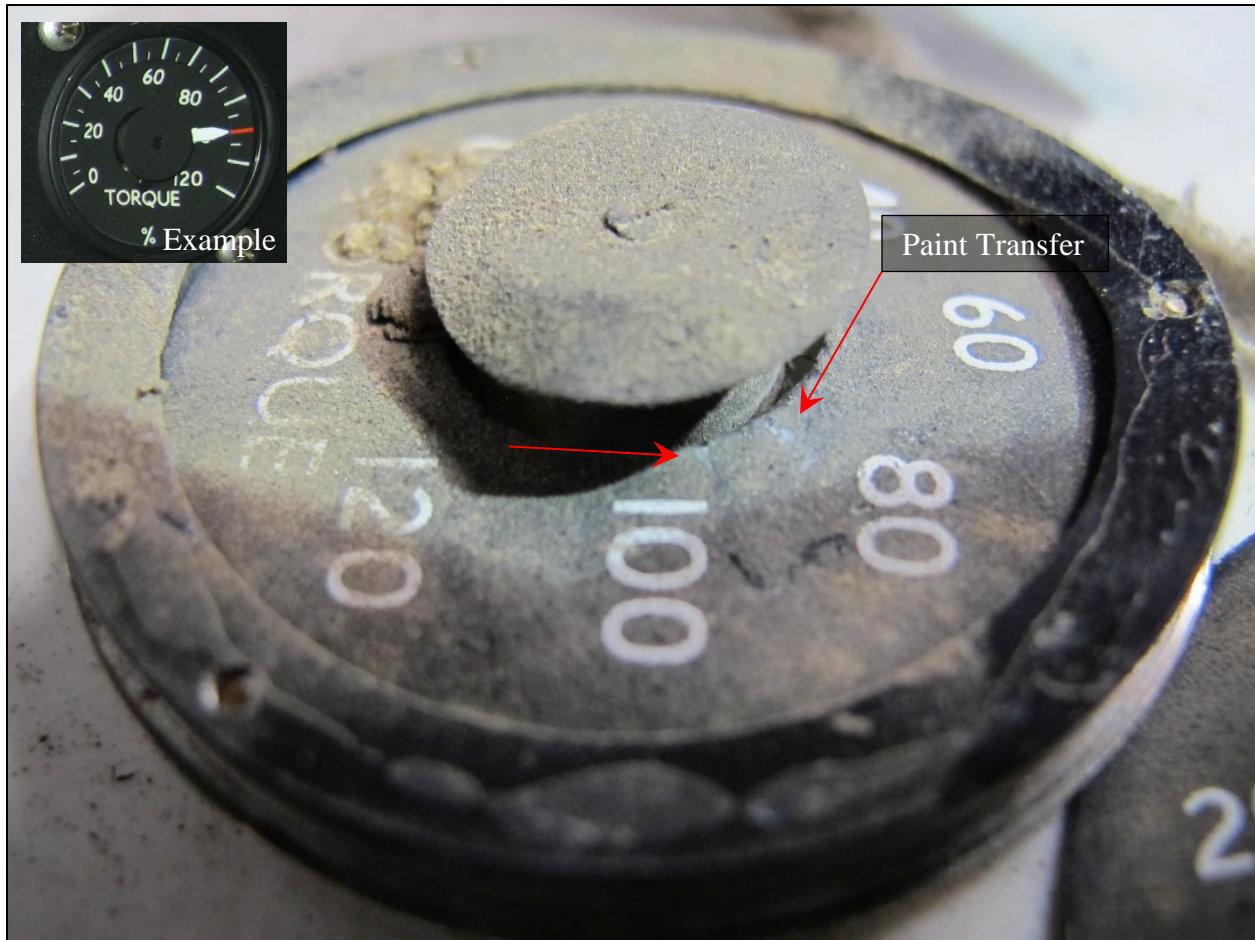
**Figure 11. Instrument, Torque**

The Torque gauge face revealed white paint transfer marks between the '80' and '100' displayed on the face.
